# Manhole Inspection Summary

# Manhole # S25Q\_\_013MH

Insp Date: **4/8/08 10:23 AM**

**Location** Address: **1501 BUSH ST.**

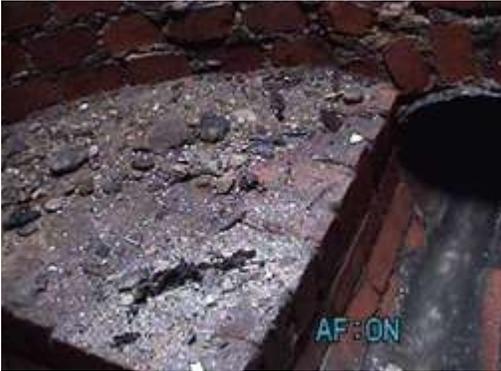
MISCELLANEOUS

LIGHT DEBRIS ON THE BENCH

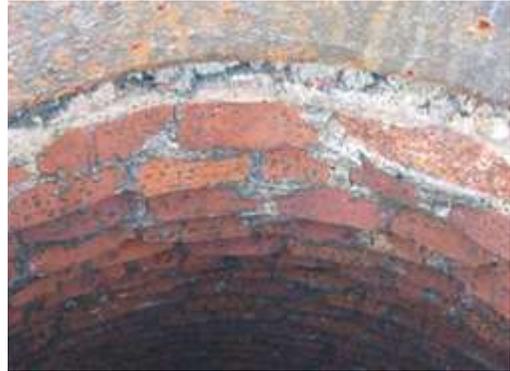
Defect 5

chimney infiltration at mortar

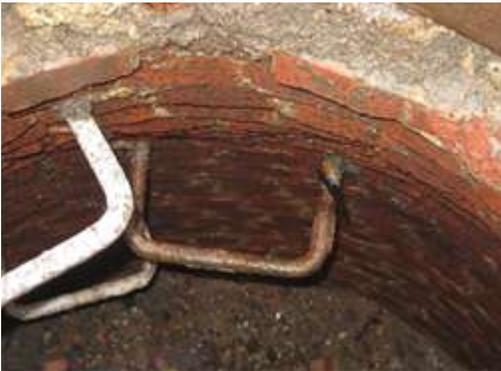
Defect 4

corroded steps

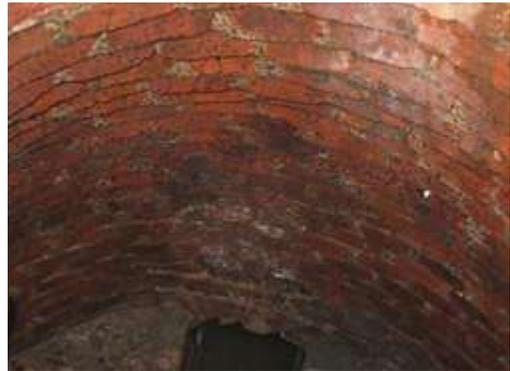
Defect 3

EVIDENCE OF INFILTRATION AT CORBEL AND BARREL WALL

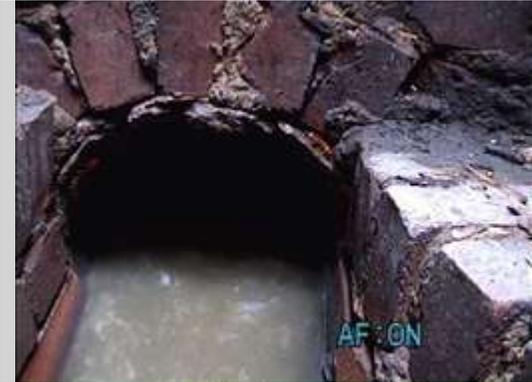
12 O'Clock Outflow

10 in. Circular Gravity Sewer  
Pipe Out @ 12 O'Clock

Pipe Height: **10.8** (in.) Rod and Bar (Angled)  
Pipe Material: **Clay**  Pipe Lined  
Invert Depth: **7.26** (ft.) Flow Characteristics: **Slow**  
Deposits:  None  Mud  Sludge  Debris  Grease  
Silt Depth: **0** (in.) Deposits Extent:  
Infiltration: **None** Pipe Seal Cond: **Unknown**

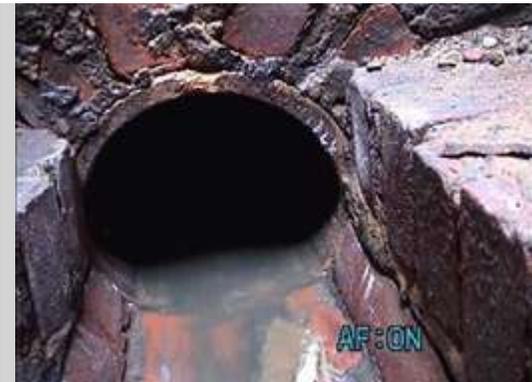
3 O'Clock Inflow

8 in. Circular Gravity Sewer  
Pipe In @ 3 O'Clock

Pipe Height: **8.4** (in.) Rod and Bar (Angled)  
Pipe Material: **Clay**  Pipe Lined  
Invert Depth: **7.11** (ft.) Flow Characteristics: **Slow**  
Deposits:  None  Mud  Sludge  Debris  Grease  
Silt Depth: **0** (in.) Deposits Extent:  
Infiltration: **None** Pipe Seal Cond: **Unknown**

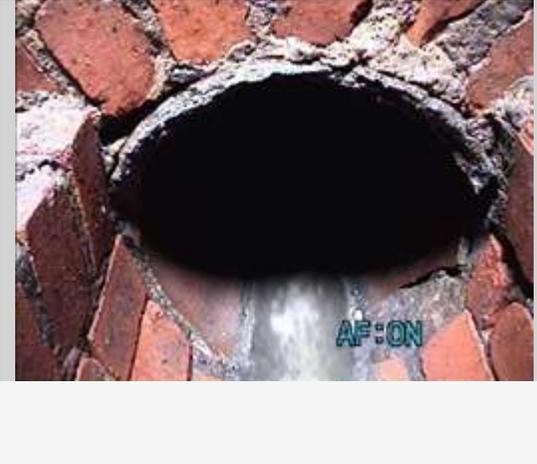
6 O'Clock Inflow

10 in. Circular Gravity Sewer

Pipe In @ 6 O'Clock

Infiltration: **None** Pipe Seal Cond: **Unknown**
